A low cost lightning protection system and its effectiveness

By: Nuwan Kumarasinghe

Electronics Engineer, Department of Meteorology, Colombo 07, Sri Lanka,
Telephone: 94-11-2681039, Fax: 94-11-2698311, e-mail: nuwan1960@yahoo.com

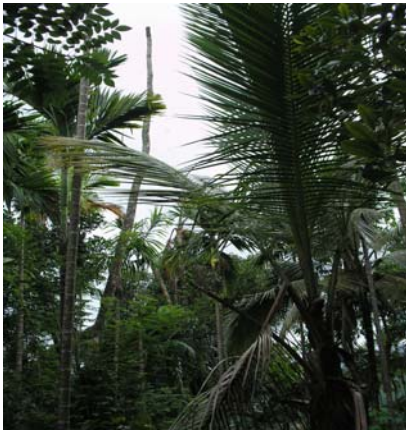
During the survey we have inspected more than 55 houses. None of them were equipped with lightning protection devices neither the villagers heard about that such a system can be used to protect their lives and property. Electricity was not available most of the houses and some people were using solar power for their day today needs. The few houses use mains power, the electrical earthing arrangement was not done properly. Some villagers do not realize the importance of the earth rod and they just ignore it .It was noticed that most of the damages in this village was due to direct lightning or side flash.

Fig. 1 A coconut tree affected by direct lightning

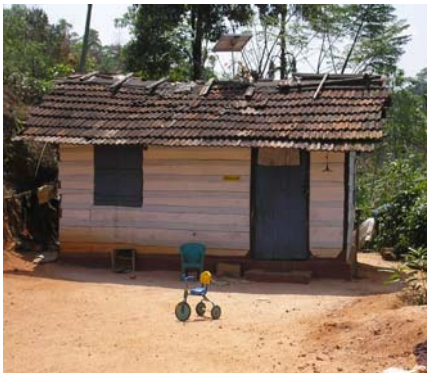
Fig. 2 A house damaged by lightning
