CASE STUDY: Transformer fault detection and repair followed by degassing monitored with online DGA

Senja Leivo, Vaisala Oyj, Finland
Juha Mertanen, Fingrid Oyj, Finland

The paper discusses a case study on a 400 MVA 400/120/21 kV transformer, installed and commissioned in a 400/110 kV transmission substation in Finland in 2003. This ONAN/F transformer is free breathing via silica-gel dehydrating breather (no rubber bag). It has ~100 m³ mineral oil (Nytro 10X).

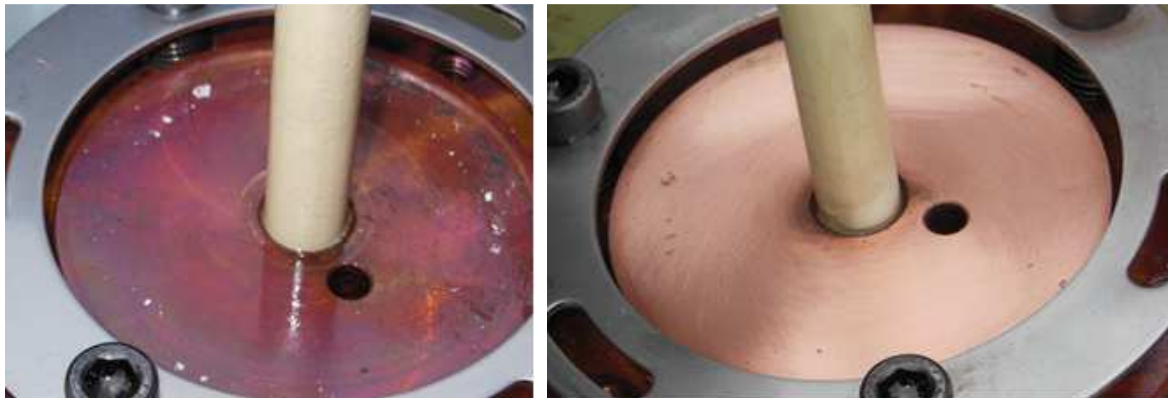
Gassing started in 2005 and was showing rising trend until 2010. Bare metal high temperature thermal fault (T3) was suspected according to the dissolved gas analysis (DGA). However the first electrical measurements in November 2010 did not reveal anything conclusive. Fault was still active and fault gases showing rising trend until 2013. This time the gases started to elevate more rapidly and the repeated DC resistance measurement identified problem to 110 kV 2a phase. Fault was located to 110 kV between bushing and winding outlet main contact. The faulty 110 kV 2a phase contact was repaired in August-September 2013.

Figure 1 Faulty 110 kV 2a bushing and winding outlet main contact before and after repairing.

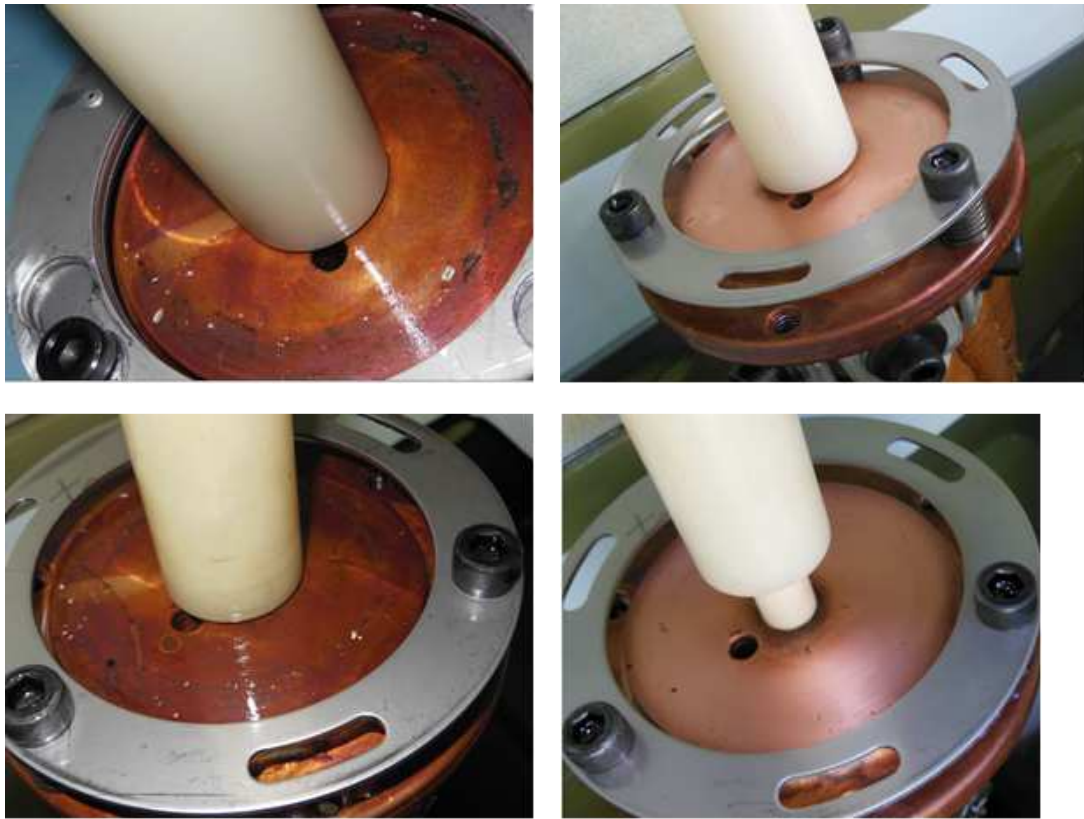
Fault gasses had then downward trend until February 2014 and started showing slow rise again until April 2014. After that fault gases started to elevate rapidly and DC resistance measurement localized problem to 110 kV 2c phase. Fault was again at 110 kV side between the bushing and winding outlet main contact and these faults were repaired in June 2014.

Figure 2 Faulty 110 kV 2b and 2c bushing and winding outlet main contacts before and after repairing.

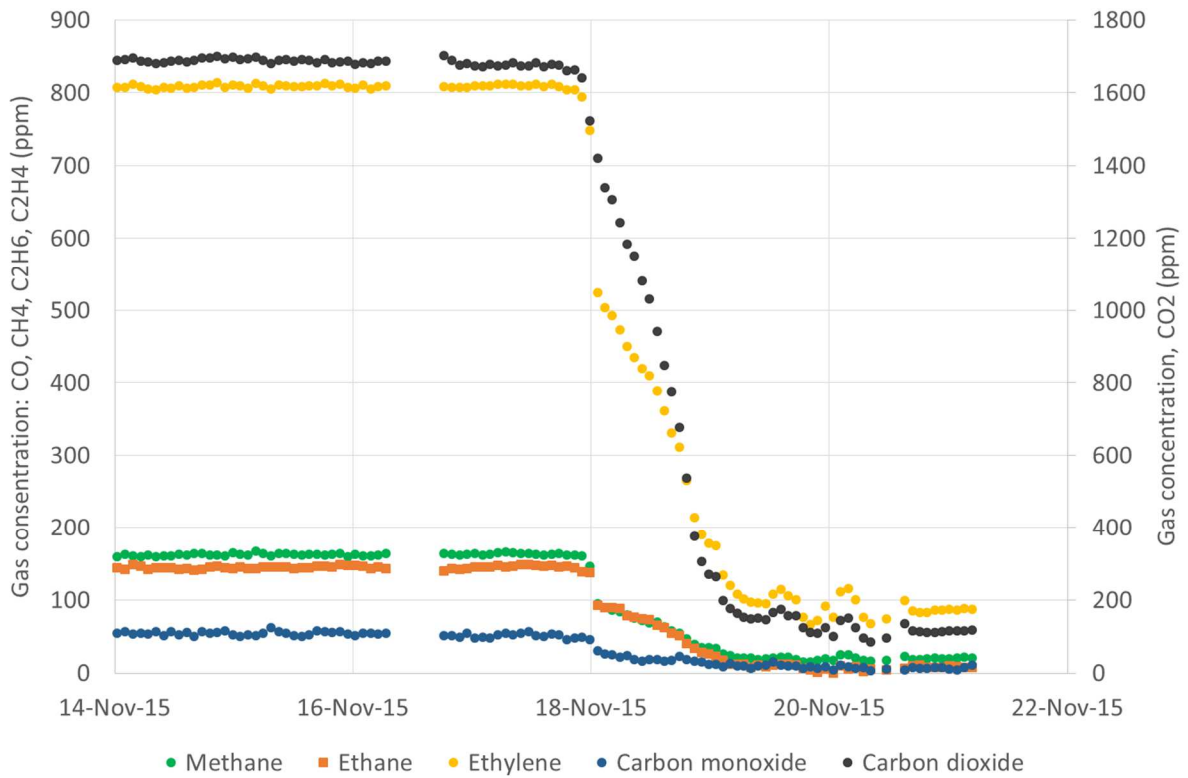
CO₂ amount in oil started to increase sharply after degassing process finished, main source probably being ambient air. Also ethylene increased clearly. However, it stabilized for two months following again with slight increase. The reference methods confirmed the increases. As of now it is not clear whether the increase in CO₂ and C₂H₄ amounts is due to that gas was “stored” in paper and released to form equilibrium between paper-oil and whole oil volume, or if there is a hot spot in oil only.

Figure 4 DGA monitoring data before, during and shortly after the degassing. Acetylene not available and hydrogen was 0 ppm already before the degassing thus removed from graph. Individual measurement points presented without averaging.

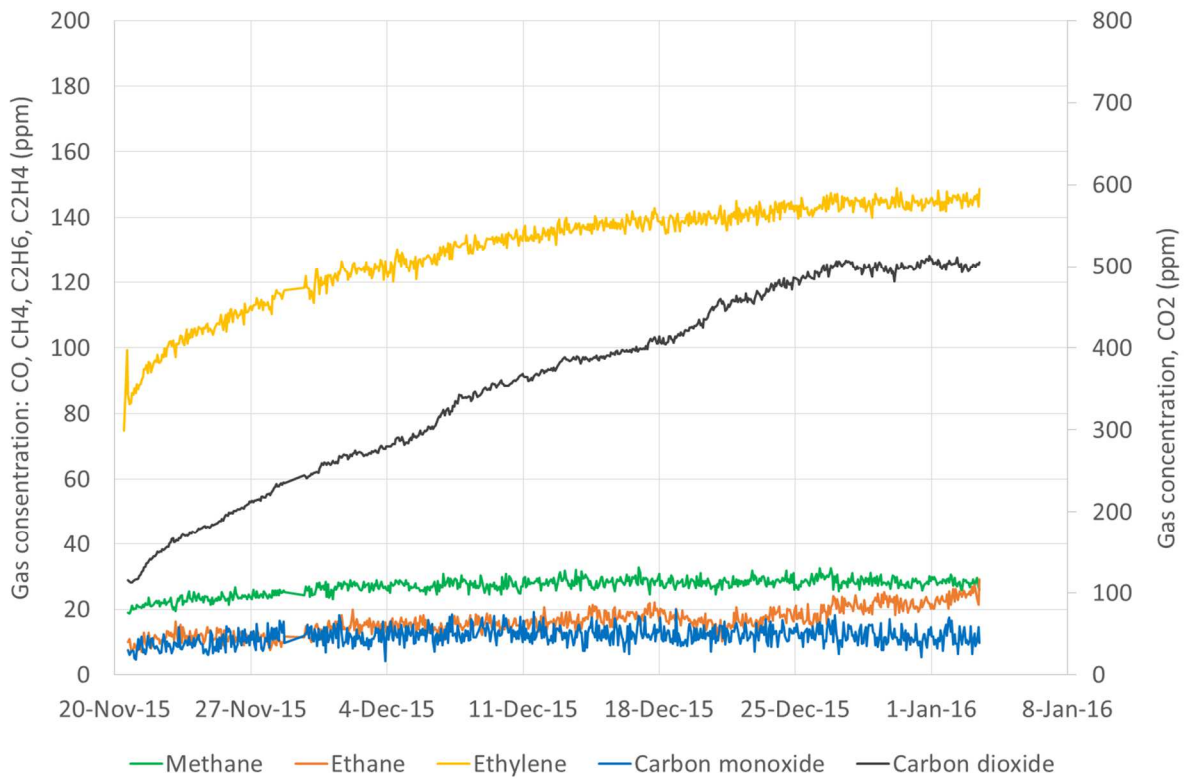
Figure 5 DGA monitoring data after the degassing. Acetylene not available and hydrogen was 0 ppm thus removed from graph.

According to Michel Duval one can expect to see roughly 7-10% of concentrations prior to degassing to recover back in oil during the following days/weeks after degassing process. This is due to gases in oil that was impregnated in paper, but did not go through the treatment. The amount may vary somewhat depending on the ratio of solid insulation to oil mass. In this case the ratio was known. However, from measured ethylene level we can conclude that it increased from roughly 70 ppm to 145 ppm within 6 weeks post degassing and then stabilizing (Figure 5). This 75 ppm increase is roughly 9% of the ethylene level prior degassing process.

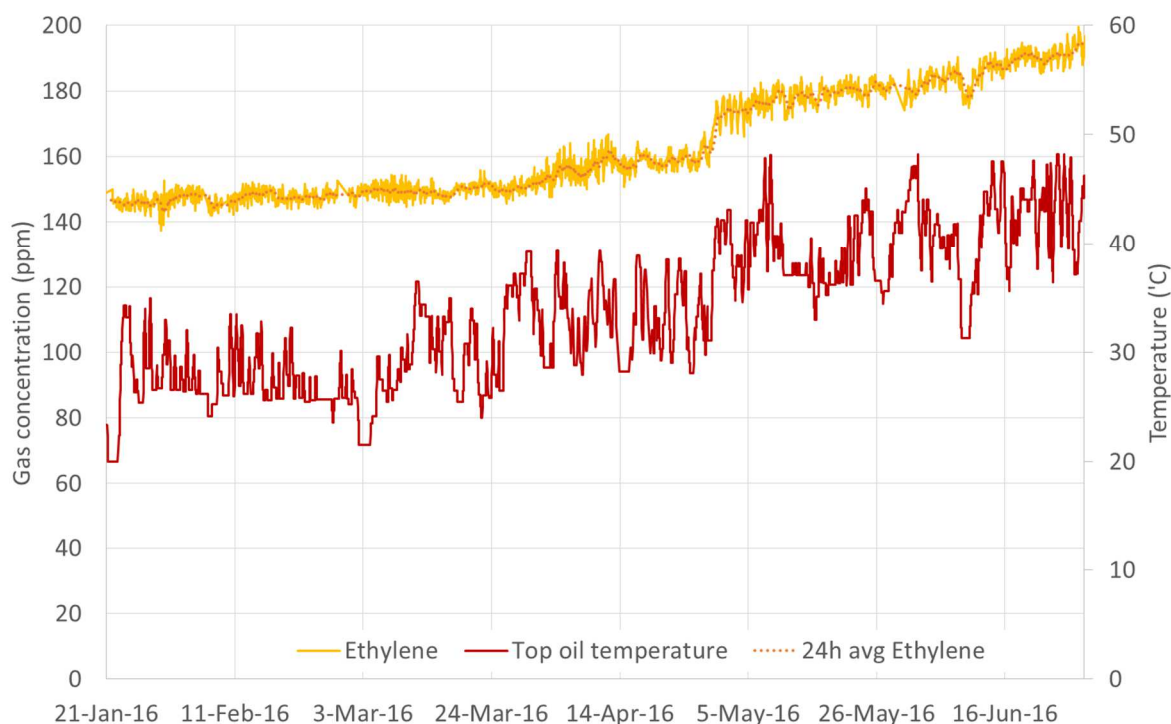
Other gases except carbon dioxide remained stable over the winter 2015-2016. In March ethylene level started to increase again having even a level step in May 2015. This gassing tendency of ethylene may relate to transformer internal actions as it appears the same time as top oil temperature level increases as well (Figure 6).

Figure 6 Ethylene concentration and top oil temperature.

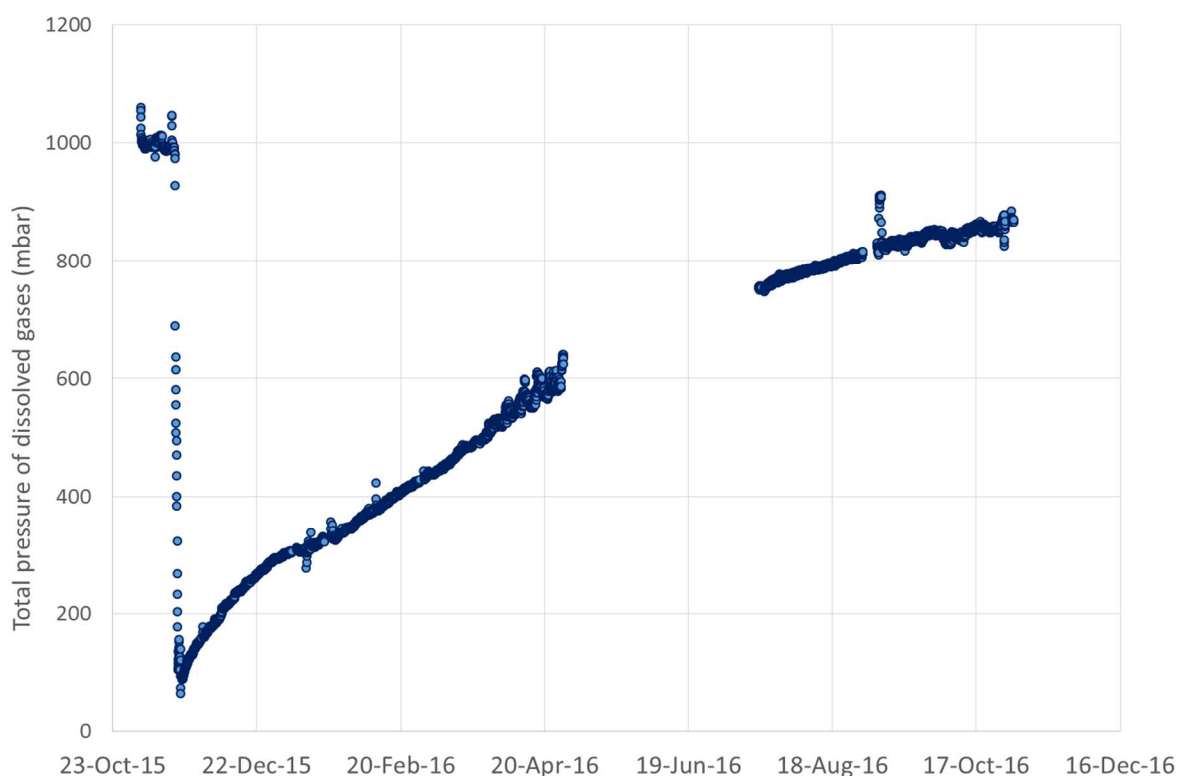
The degassing process treated the 100 m³ oil volume roughly 3 times at 80 °C during 3 days while the transformer was off-load. The process decreased gas amounts in oil to one tenth, which was confirmed both with the individual gas measurements as well as from the pressure of total dissolved gases (Figure 7). Ambient temperature varied between 0 to 10 °C during the degassing process.

Figure 7 Total pressure of all dissolved gases before, during and after degassing process.

Surprisingly the total gas pressure in oil has not reached equilibrium with ambient air pressure even almost one year after degassing (Figure 7). Although it is free breathing transformer the gas diffusion through long tube between the tank and the conservator is very slow process under low temperatures. Also light loading has kept the oil level very stable in the conservator so that there has not obviously occurred real breathing.

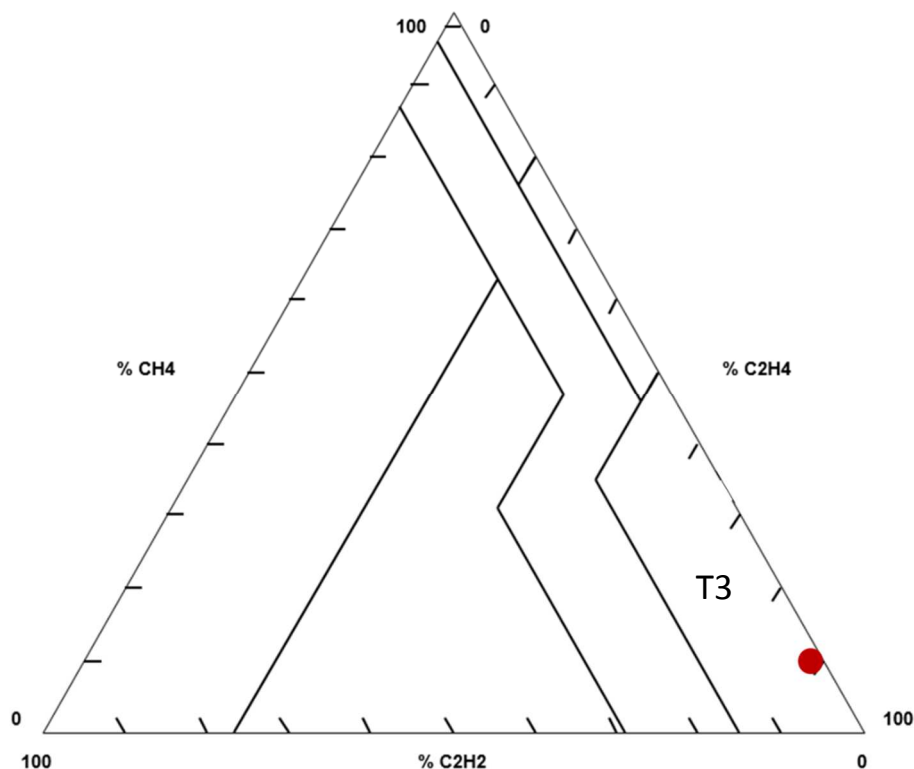
As of now it is not clear what the reasons for increasing gas levels are, even under rather low load and temperature. When looking at Duval triangle, the measured online data would suggest T3 high temperature fault. The same time there has been some increase in CO and significant increase in CO₂ which may also indicate paper being involved.

Figure 8 Duval triangle with online data point 11 months after the degassing.
