Preserving our Antarctic Heritage - Mawson's Huts

The Historic Site - the "Home of the Blizzard"

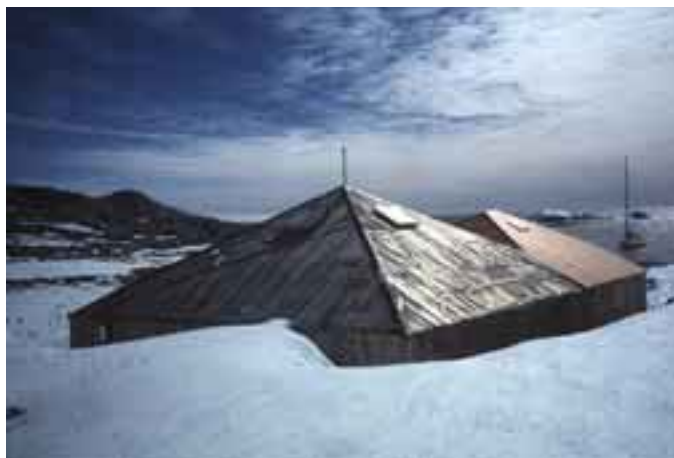
The Mawson's Huts Historic Site and associated elements is a complex cultural landscape that illustrates, in its surviving form and setting, the isolation and harsh conditions encountered by the original expedition members.

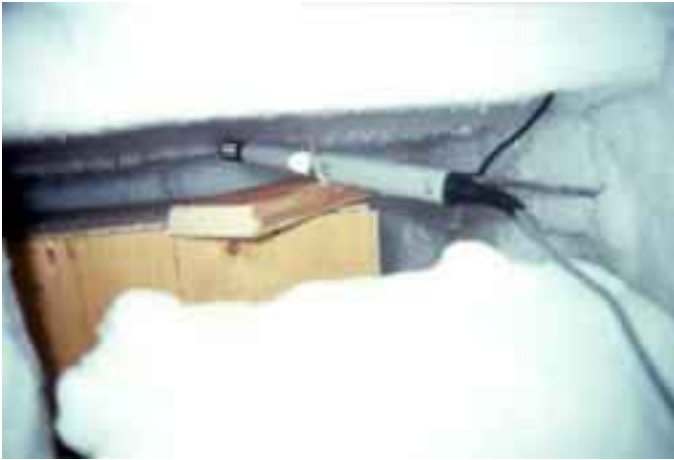
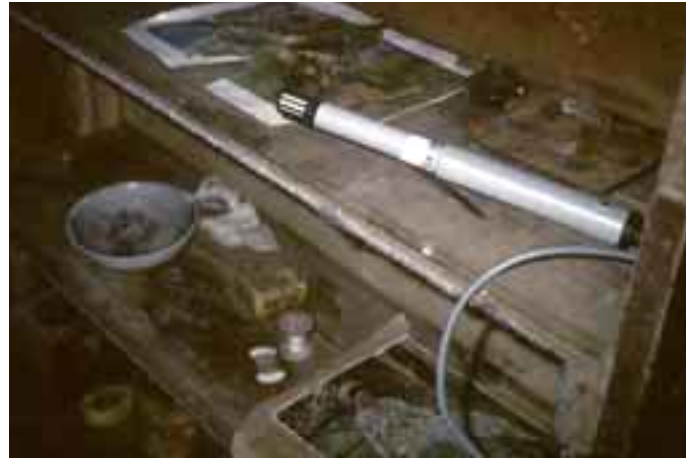
To further understand the deterioration processes affecting the building structure and artifacts, equipment for monitoring temperature and relative humidity, corrosion, salt deposition and erosion of timbers was installed in 1999.

A Campbell Scientific CR10X monitoring system was used, with eight combined Vaisala HM35A Relative Humidity Temperature Transmitters and 10 surface temperature thermocouple sensors variously placed from floor to ceiling height and from the outer walls to the center of the Hut to record differing conditions within the building.

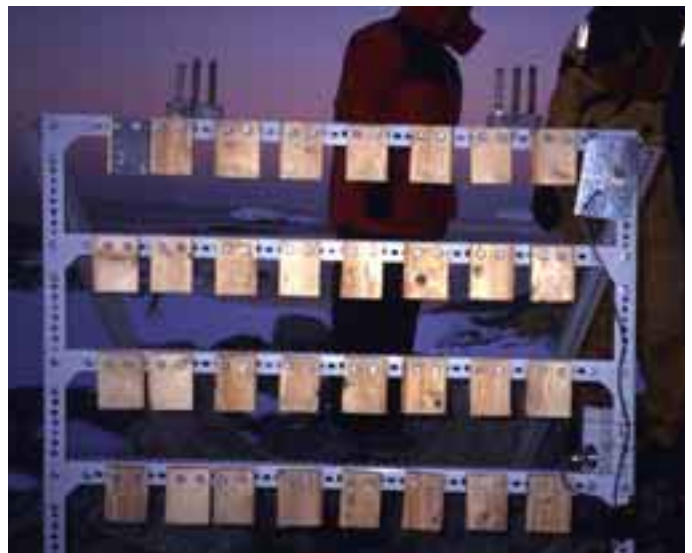
CSIRO has been providing expertise in monitoring corrosion rates at Mawson's Hut since 1983. Although Antarctic temperatures do retard the two most important factors in timber deterioration - fungus and insects - the common belief that the freezing climate will prevent biodeterioration and corrosion, a la 'perfect preservation', has been exposed as a myth.
