23rd International Lightning Detection Conference  
18 - 19 March • Tucson, Arizona, USA  
5th International Lightning Meteorology Conference  
20 - 21 March • Tucson, Arizona, USA

## Overview of the Kansas Windfarm2013 Field Program

**Abstract**—Recently, there has been renewed interest in the study of lightning attachment to tall objects in general, and wind turbines in particular, following the construction of large wind farms in lightning-prone regions. Initial observations of lightning attachment to wind turbine generators at a Kansas wind farm in 2012 resulted in a number of insights and left several open questions. This led to the planning and re-deployment for the summer of 2013. Ten groups have collaborated on this 2013 field project, resulting in the following suite of instruments and observations: 10-station 3D lightning mapping array (LMA), 8-station slow antenna array, 4 electric field mills, 2 continuous, standard-speed, fixed-location video cameras, three mobile high-speed video observation vehicles, remote charge-moment observations, remote low-light cameras focusing on upper-atmospheric discharges, and upgraded U.S. National Lightning Detection Network observatio

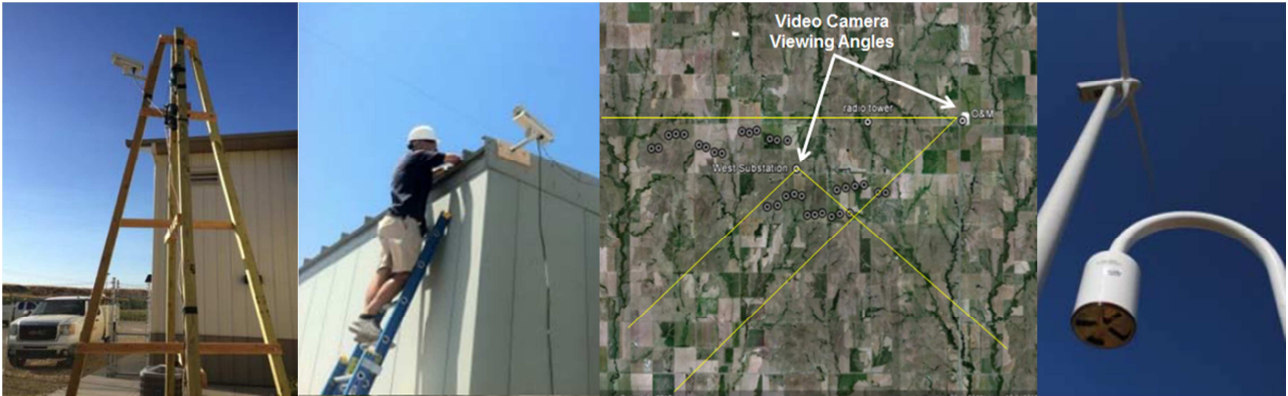
Fig. 2. (From Left to Right) Video camera installation at the Operations & Maintenance Building; video camera installation at the sub-station; map of the video camera viewing angles; view of an electric field mill installed at the wind farm

Observations for the 2012 campaign included standard-speed video observations from two cameras, static electric field using two electric field mills, NLDN observations of cloud-to-ground (CG) return strokes, and *in-situ* current transient measurements in all turbine blades reported by the “Supervisory Control and Data Acquisition” (SCADA) system. The two digital video camera systems (60 fields-per-second) were configured to self-trigger 2-second video sequences using a sequential-field-subtraction scene analysis (ufo-Capture). The two cameras had a small common field of view that included 8 of the wind turbines. Nearby NLDN sensors were configured to record information that allows reconstruction of magnetic field waveforms within the bandwidth of the NLDN sensors. The on-site instrumentation is shown in Figure 2.

The electric field mills (EFMs) and standard-speed automatic cameras were the same ones that were used in 2012, as shown in Fig. 2. The EFM locations where changed in 2013, indicated by arrows in Fig. 3. The NLDN observations included both cloud and cloud-to-ground discharges, as well as continuous waveform data. In addition, all turbine generators were equipped with devices that provide estimates of lightning peak current within the blades, as was the case in 2012.

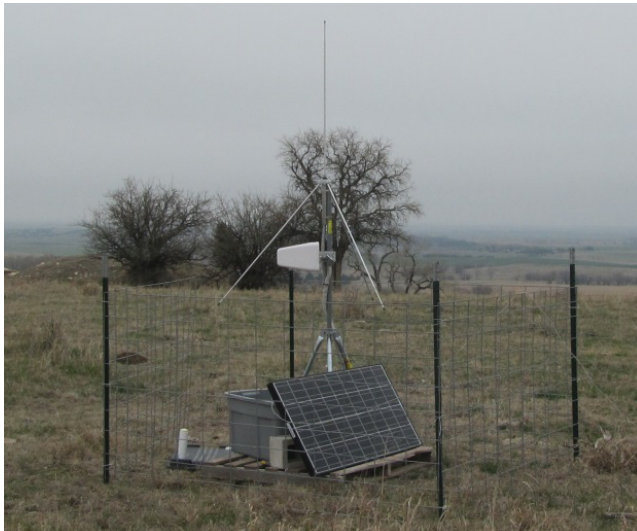
Fig. 4. Portable Lightning Mapping Array (LMA) Station.

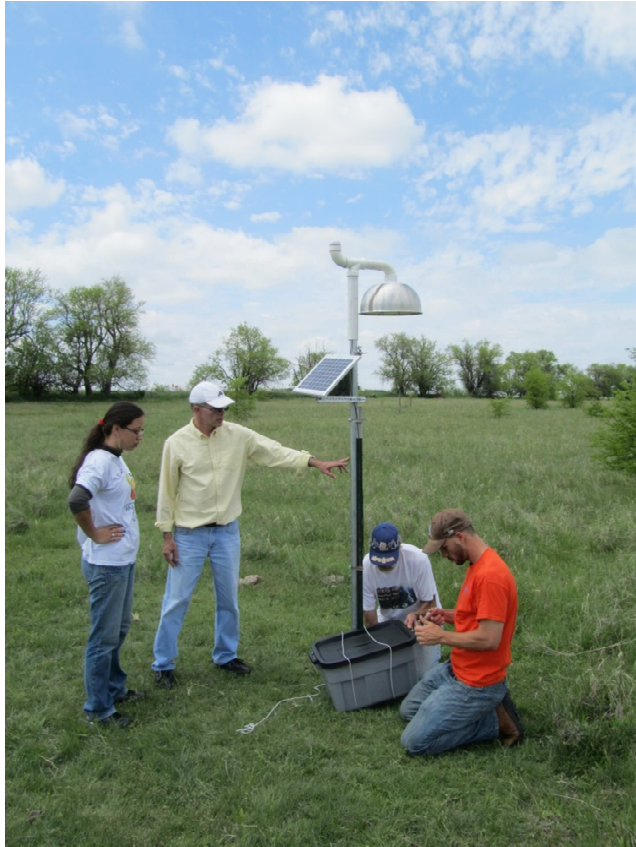
Fig. 6. New Mexico Tech solar-powered slow antenna installation. Battery box is being installed by Ron Thomas and Mason Quick, while being well-managed by our illustrious Brazilian team.

The 8-station slow antenna network provided information about the times, locations, polarity, and magnitudes of lightning processes associated with significant charge transfer. The slow antenna sensors, designed by New Mexico Tech, had a low-frequency time constant of 10 seconds, and an upper frequency response of 25 kHz. The data were sampled at a 50 kHz rate. The nominal sensitivity of the sensors allowed them to accurately measure field changes in the range of 10 mV/m to 10 kV/m. Fig. 6 shows one of these slow antennas as installed in Kansas.

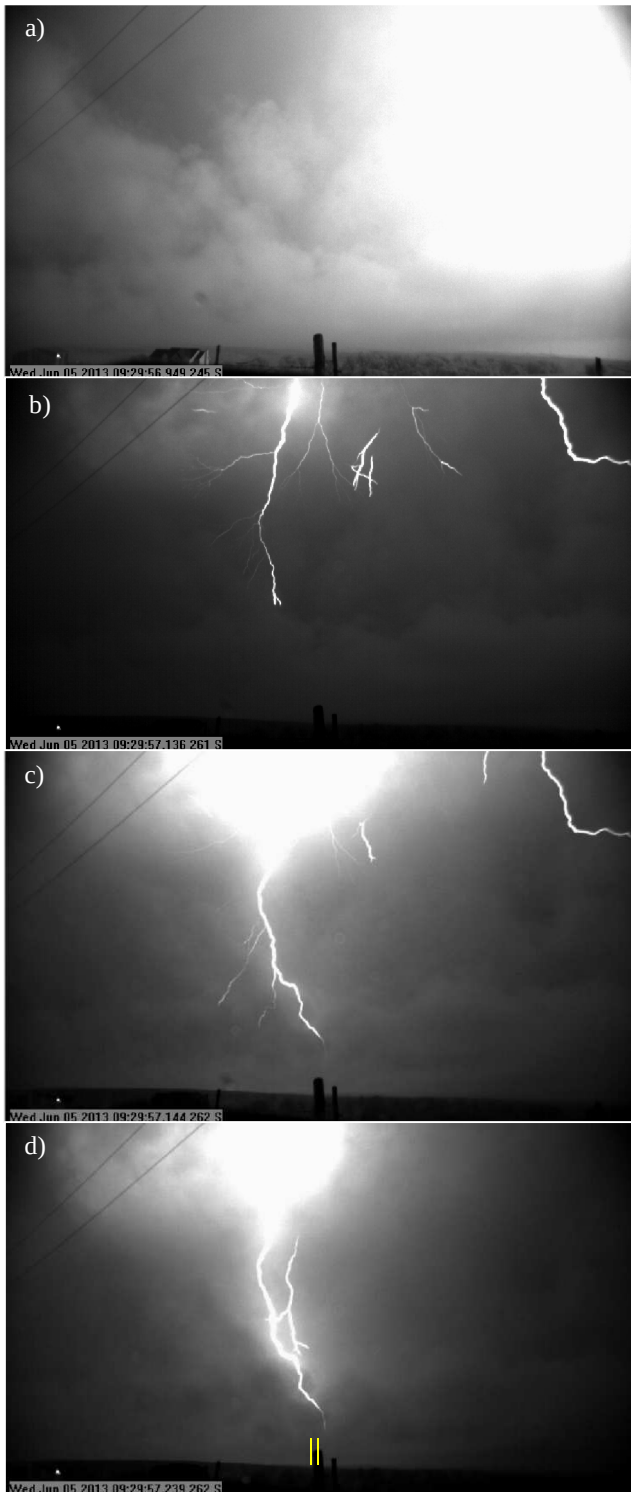
Fig. 15. Video frames from the 2-turbine flash on June 5, recorded by the Miro 4 camera recording at 1000 fps. (a) diffuse illumination from earlier +CG stroke ~50 km south-southwest of the camera location; (b) image of downward propagation positive leader about 8 ms before the +81 kA return stroke that struck the turbines; (c) just prior to +81 kA return stroke; (d) 95 ms after the return stroke. Yellow bars represent turbines that had SCADA reports.

Some portions of this particular flash were also caught on high-speed video, using a Miro 4 camera at 1000 fps. Four frames during the flash are shown in Fig. 15. Fig. 15a is the 1 ms frame that included the time of the first +CG stroke that was located south-southwest of the wind farm. This activity produce a large bright “blob” in the upper-right portion of the

field-of-view. About 200 ms later, a number of framed depicted the downward propagating leader for the +CG stroke that impacted the two turbines. Fig. 15b shows one frame during the leader descent and Fig. 15c shows the last frame before saturation during the return stroke. The continuing current following the return stroke lasted for 94 ms. Fig. 15d is the first non-saturated field following the return stroke. Note that the leader channel is in exactly the same location as before the return strike (Fig. 15c), and shows no evidence of two separate channels near ground. The two yellow lines near the ground in Fig. 15d are the best estimates of the locations for the two turbines that reported current transients. The one on the right reported the highest current (16 kA), and the one on the left reported the lowest value that the SCADA system is capable of reporting (6 kA). As noted in Section II.D, these SCADA current values do not correlate well with NLDN estimated peak current, even when we had video evidence of direct attachment of a downward negative leader to the reporting turbine.
