# Lightning attachment process to common buildings

**Abstract**— In this paper we analyze upward connecting leaders induced by some downward negative lightning flashes that struck an ordinary residential building located in São Paulo City, Brazil. Most of what is known about the current of downward flashes comes from information gathered on towers. There are no observational data of lightning attachment to common structures or buildings (under 60 m) that are present in almost every city. For the first time, the attachment process was analyzed by a high-speed camera running at 10,000 images per second. The striking distance observed was larger for return strokes with higher peak currents. The ratios of speeds of the downward leader and the upward connecting leader varied from 1 to 9. The final jump discharge initiated from the positive upward connecting leader

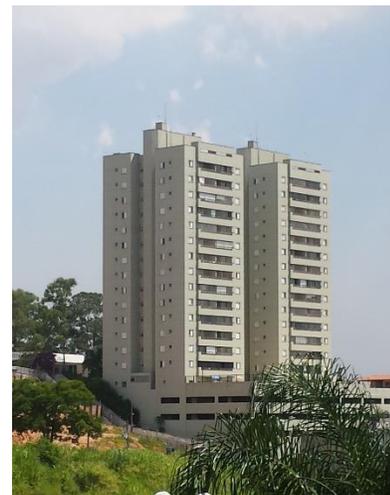
Fig. 1. Identical buildings (P2 on the left, P1 on the right), both have the same LPS installed.

The present study presents results from measurements of cloud-to-ground lightning flashes that struck a pair of common identical 14-story apartment buildings (Figure 1) in São Paulo City (southeastern Brazil). The tip of their lightning rods is at a height of 52 m. Their steel reinforced concrete structures are used as natural LPS. The flash density  $N_g$  for the region is about 11 flashes/km<sup>2</sup>.year [ELAT, 2015].

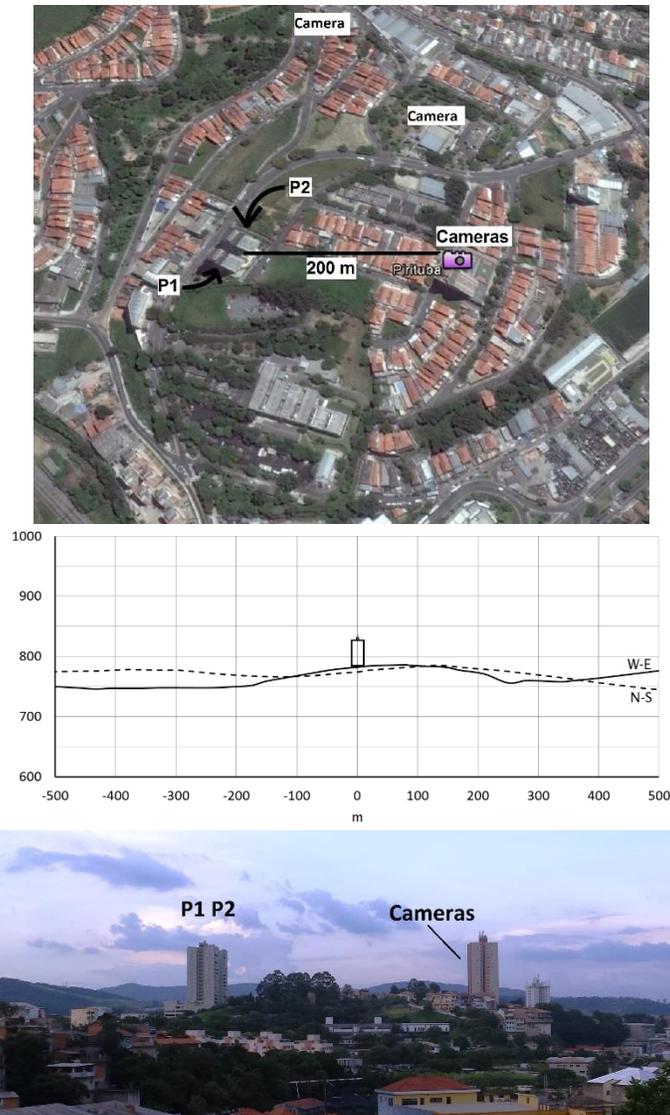
Fig. 2. a) Location of the twin buildings P1, P2 and cameras; b) approximate elevations (m) of the terrain along two directions: West to East (solid line) and North to South (dashed line), taken from Google Earth. The building is drawn on W-E elevation curve in scale; c) a side view of buildings P1 and P2 and the building where most cameras are placed.

Figure 2 shows the locations of the two buildings and cameras, the topography of the terrain within 500 m of the buildings, and a side view of P1 and P2 together with the place where high-speed cameras are located. It can be seen that the buildings are on relatively flat terrain in terms of lightning attraction.

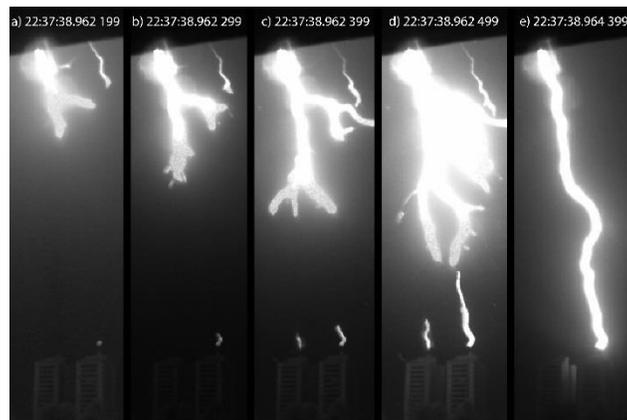
Fig. 4. Sequence of video images showing the initiation and development of an UCL and two UUL on February 9th, 2014. The UT time of each video frame (stamped at the end of the frame integration) is given as hh:mm:ss.xxx yyy (xxx digits are milliseconds and yyy are microseconds).

In this paper we will present discussions about three lightning attachment cases observed on lightning rods of the twin buildings P1 and P2. In all cases we observed that the UCL was always accompanied by an UUL from the other building, as shown in Figure 4.

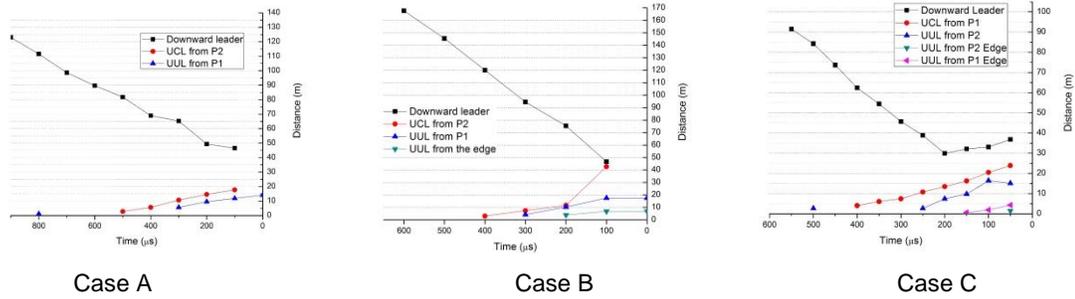
Fig. 5. Distance travelled by each leader as a function of time in 100- $\mu$ s intervals.

The analysis of displacement and speed of the downward leader and the corresponding UCL and UUL are presented in Figures 5 and 6. Time 0 is set at the beginning of the return stroke.

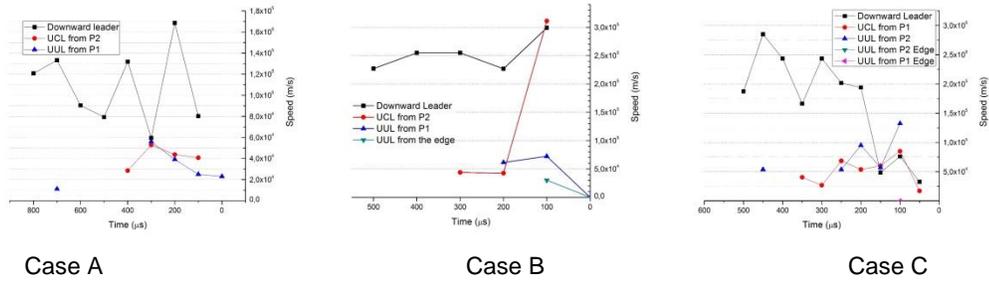
Fig. 6. Average speed for each leader in 100- $\mu$ s intervals.

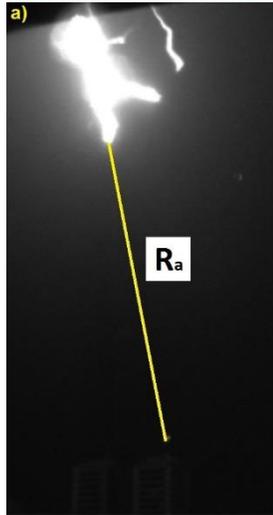
Fig. 7. Striking distance for case B (120 meters).

The striking distance, a concept that has been widely used in lightning protection studies, was defined by Golde [1973], as the separation between the tip of the stepped leader and the tip of a grounded structure when a stable upward connecting leader is initiated from the tip of the structure (Figure 7). According to this definition, the striking distances for the cases are shown in Table 1.
