## Identifying Hot Spots with the OPT100 Online DGA monitor

The Vaisala OPT100 was installed at CTM Salto Grande on the Argentina – Uruguay border, to evaluate gassing problems on a 50/50/100 MVA transformer, so that it could be studied over varying operating conditions over 1 year to determine if there was a correlation between gas levels and operating conditions, such as loading and top oil temperature.

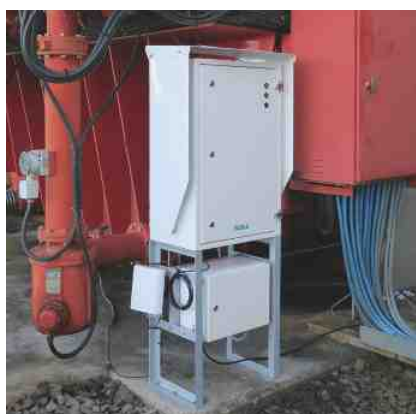
*Figure 1. The installed online DGA monitor OPT100. The inlet and outlet oil pipes are connected to the bottom drain valves.*

In June 2017, the Vaisala OPT100 multi-gas DGA was installed to measure the key fault gases in real time (Figure 1). The monitor was connected to the transformer while live as the operating conditions of the hydropower plant didn't allow for stoppages. Due to the unique design of the OPT100 this wasn't an issue and installation was completed in half a day.

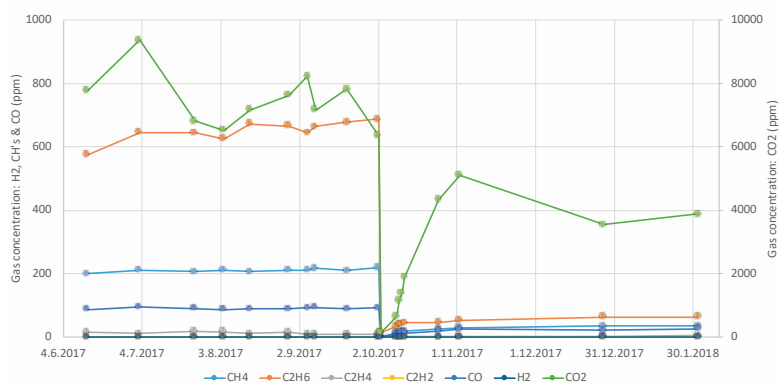
Figure 2. Lab results for the DGA samples.

For one year the Transformer Maintenance Team analyzed the DGA data and compared it to the transformer operating conditions to see if there was any correlation between the two. Every two to three weeks during this process CTM Salto Grande took oil samples to analyze in their lab for comparison (Figure 2).

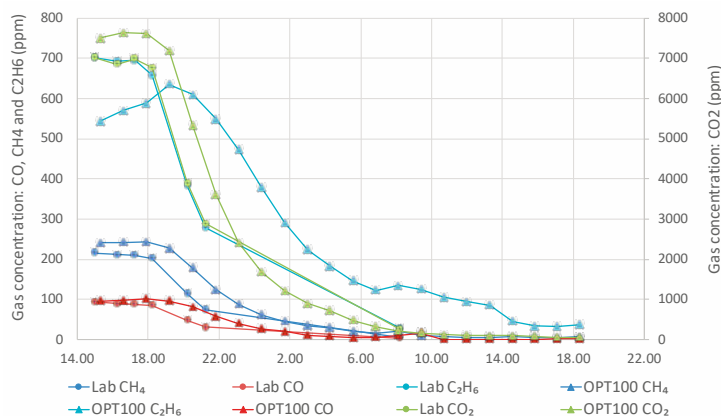
Figure 3. OPT100 response during degassing phase compared to lab sample analysis.

The transformer was degassed in October 2017. During this process, the OPT100 continued to measure. At the same time, lab samples

were taken every two hours. A comparison of the two sets of results can be seen in Figure 3.

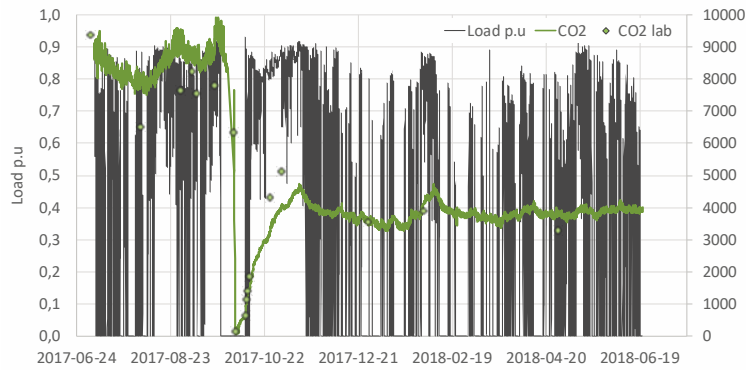
Figure 4. CO<sub>2</sub> vs load over the trial period.

Figure 4 shows the transformer loading and CO<sub>2</sub> concentrations in oil, measured by the OPT100 online monitor and the laboratory references, demonstrating a clear increase in CO<sub>2</sub> during high loading periods. When the load was lower or varying, the CO<sub>2</sub> remained stable or even decreased. This could indicate that during longer periods of high loading, there is a hotter area inside the transformer causing CO<sub>2</sub> formation from either paper or oil.

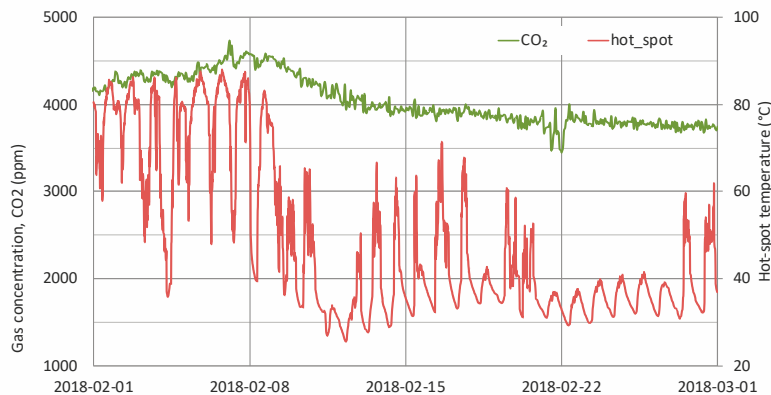
Figure 5. Calculated hot spot temperature and CO<sub>2</sub> concentration in oil over a one-month period.

$$T_{\text{Hot Spot}} \approx T_{\text{Top Oil}} + H * gR * \text{ipu}^2,$$
where gR is the average temperature difference between winding and oil measured at the factory during FAT and H = 2 is the estimated hot spot factor (Figure 5).

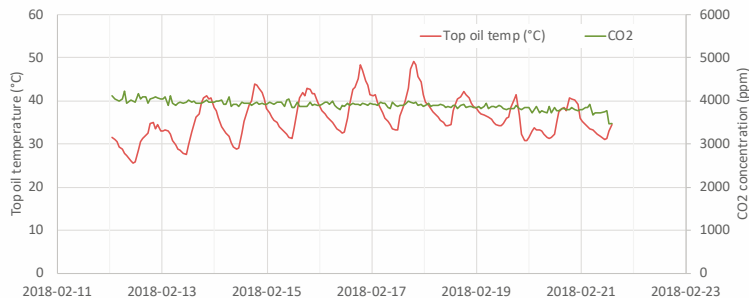
Figure 6. Top oil temperature and CO<sub>2</sub> concentration in oil over a period of approx. one week.

Several math models were tried using the estimated hot spot temperature: a linear one and another with a threshold for the hot spot to act on the CO<sub>2</sub> concentration, estimated at around +70°C. More work is needed to refine the models. However, it is not a simple correlation, since it is possible that there is a large CO<sub>2</sub> exchange over time that is not visible in data covering just a few days (Figure 6).

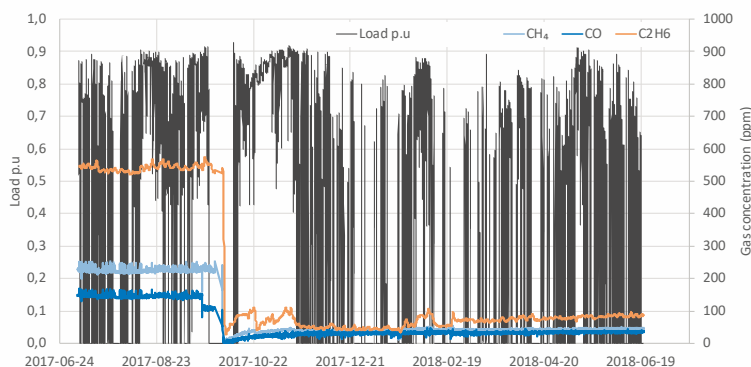
Figure 7. Other fault gases and load over the trial period.

The other fault gases, except probably C<sub>2</sub>H<sub>6</sub>, did not show any clear correlation with loading during the trial period (Figure 7). The increase in gas levels right after degassing is most likely due to gases that were in parts of the oil that were not available for degassing, like oil impregnated in paper and oil stuck in tight spaces. When this oil diffused back into the treated oil, gas levels increased.

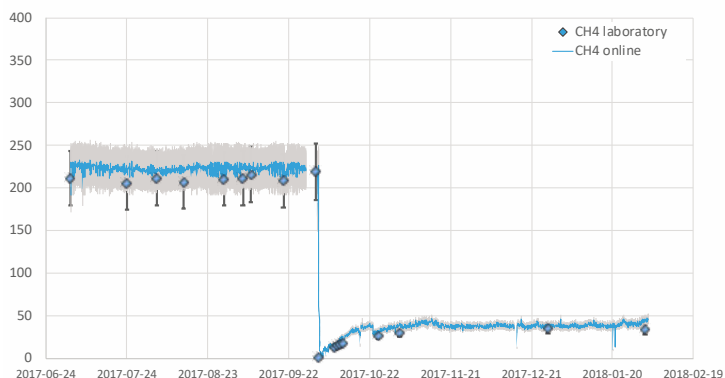
Figure 8. OPT100 DGA monitor methane readings with  $\pm 10\%$  accuracy (gray area) plotted with laboratory reference with  $\pm 15\%$  error bars.

In addition to the response time, the monitor readings were compared to the laboratory DGA results over the whole period. For simplicity, only methane is shown in Figure 8. The blue line is the measurement data from the monitor and the grey area is the monitor's accuracy specification. The lab references are shown as blue dots.

In this case, since the uncertainty of the laboratory was not known, +/- 15% was used, based on the average lab accuracy examples published in IEC 60567 [3]. Therefore, in order to compare a lab to an online DGA, it is more relevant to compare the trends than actual measurements. If the trends are similar and the areas with uncertainties are overlapping, you can conclude that the two different methods are in broad agreement.

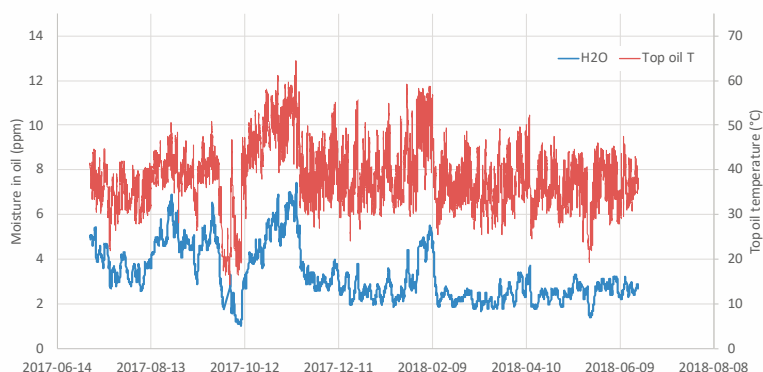
Figure 9. Oil moisture in ppm and top oil temperature over time.

The moisture in transformer oil varies as the temperature fluctuates either due to loading, ambient temperature, or both. This effect was seen in this study as shown in Figure 9. The top oil temperature and the moisture in oil (ppm) is shown over a one-year period. It shows how moisture is released from the insulating paper surface into the oil when the temperature increases and then absorbed back into the paper when the temperature decreases.

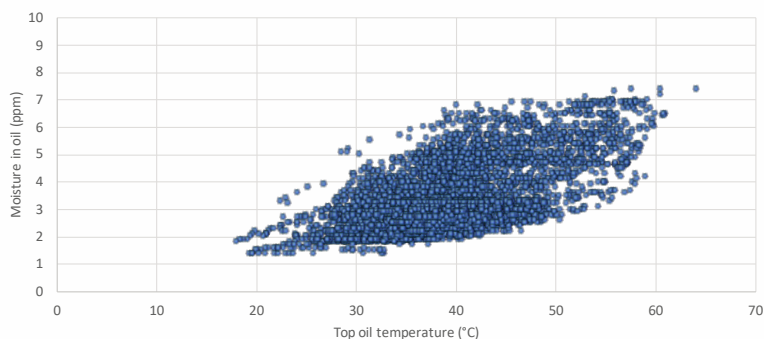
Figure 10. Oil moisture vs. top oil temperature.

However, water desorption is a faster process than absorption, and thus there is clear hysteresis visible when moisture as ppm is plotted against top oil temperature (Figure 10). This means a transformer with a varying load is never in equilibrium.
