## Use of Mobile Online DGA for Gassing Alarm Response and Analysis

### Using Mobile Online DGA for Cost Effective Deep Analysis of Questionable Gassing Transformers

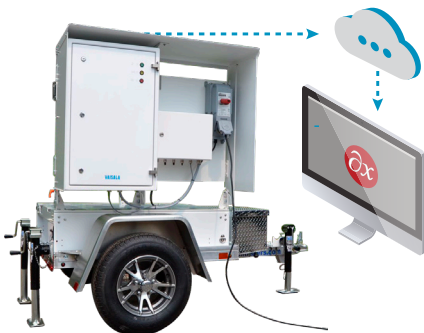
Figure 4: Vaisala OPT100 Mobile DGA monitor.

AES Indiana had been evaluating mobile online DGA solutions and decided to purchase an OPT100 Mobile online DGA and moisture monitor from Vaisala. They felt this tool could address the need for a “middleware” solution to gather live data to TOA. (See Figure 1.) The question still remained regarding how easy this type of a system would be to install and move and how reliable the gas measurement results would be, so close attention was paid to the first installation.

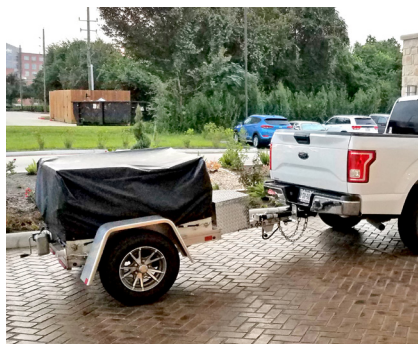
OPT100 Mobile ready to be pulled to a transformer site.

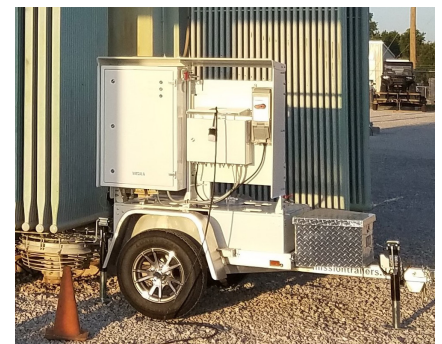
OPT100 Mobile Installed on a transformer.

The OPT100 Mobile online monitor was installed on the transformer in February of 2020 just south of Indianapolis. The device was left in service for 4 months, gathering DGA data for analysis. During the installation, the transformer was left energized as the connection points were low enough on the transformer to be reached safely and the OPT100 Mobile does not require an outage for installation. The installation and commissioning were completed by 2 people working for a half day, which included setting up the remote comms. No special equipment or connectors were needed, nor was any proprietary software required. Just a laptop and a browser.
