# Lightning Attachment to Wind Turbines in Central Kansas: Video, Observations, Correlation with the NLDN and in-situ Peak Current Measurements

Nicholas Wilson<sup>1</sup>, Jackson Myers<sup>2</sup>, Dr. Kenneth Cummins<sup>3</sup>, Matt Hutchinson<sup>2</sup>, and Dr. Amitabh Nag<sup>4</sup>  
<sup>1</sup>Vaisala GmbH, Hamburg, Germany <sup>2</sup>EDP Renewables, Houston, USA <sup>3</sup>University of Arizona, Tucson, USA <sup>4</sup>Vaisala, Inc., Boulder, USA

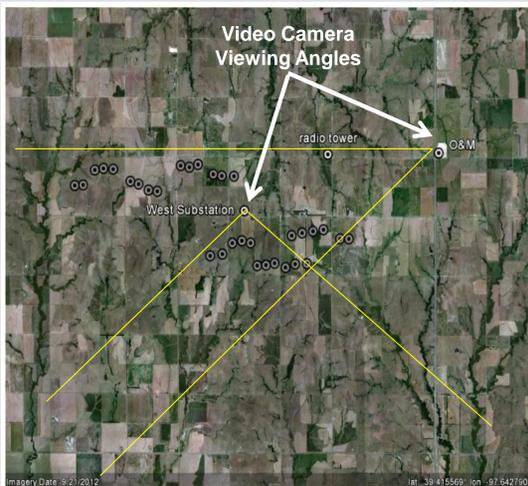
## OBSERVATION SYSTEMS

- Two (2) 60 fps PC-based systems using ufoCapture software

- Current in conductor attached to receptors on blades

- US National Lightning Detection network (NLDN) cloud-to-ground stroke and in-cloud flash data

- Electric field mills, radiation waveforms from lightning sensors and radar data

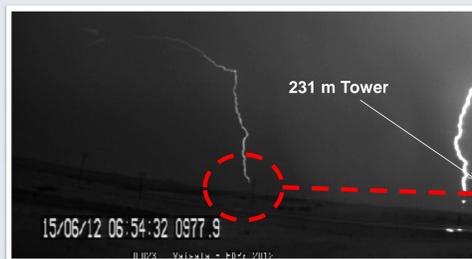
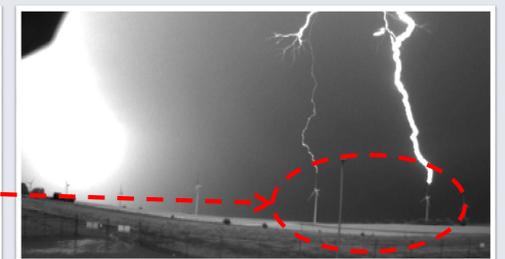
15 June 2012

- +CG triggers upward lightning from two (2) turbines and a radio tower simultaneously

- Seven (7) turbine strikes recorded, three (3) of which were upward
- Two (2) radio tower strikes were recorded, one (1) of which was upward
- Two (2) had no return strokes (triggered by nearby +CG stroke)

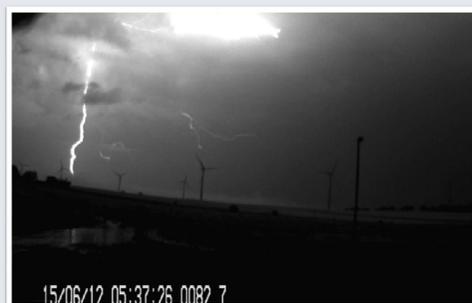
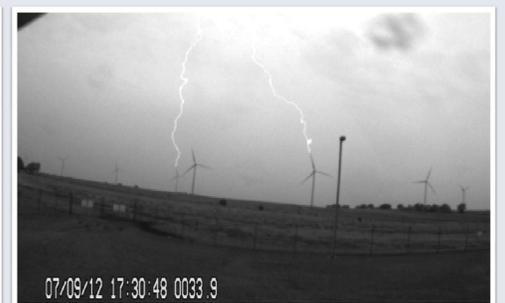
7 September 2012

- CG strikes to two (2) turbines with both causing blade damage
