# ULTRASONIC WIND SENSOR UNDER FREEZING CONDITIONS

Jarmo Hietanen, Tuomas Aaltio, and Mirka Moisio  
Vaisala Oyj, Vanha Nurmijärventie 21, P.O.Box 26, FI-01670, Finland  
+350-9-89491, jarmo.hietanen@vaisala.com

## ABSTRACT

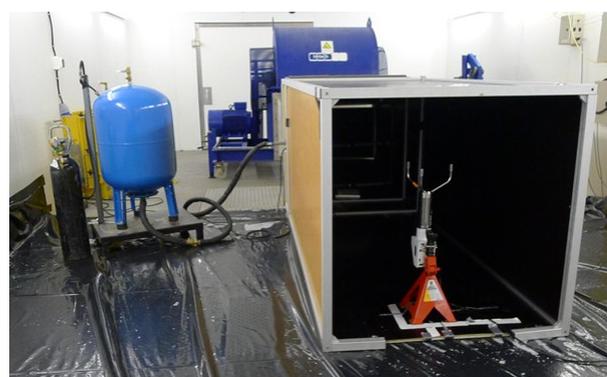
**Figure 2.** Test set-up includes water tank (blue), radial blower, air channel, water spraying nozzles, and UUT inside climate cabinet.

The A-procedure has 25 mm ice accumulation with air flow of 9 m/s. To ensure sub-zero temperature of all structures, the pre-condition of the test is cold soak of 3 hours with temperature lower than -17 Celsius degrees. Then the climate cabinet temperature is raised to -6 Celsius degrees. Icing starts by spraying pre-cooled water with wind. Ice accumulation on non-heated structures is adjusted to be 25 mm. After ice accretion of 25 mm is obtained, the water spray is shut off and the UUT exposed to the specified wind for a minimum of 30 minutes. Figure 1 presents the procedure. Figure 2 shows the test equipment inside climate cabinet.

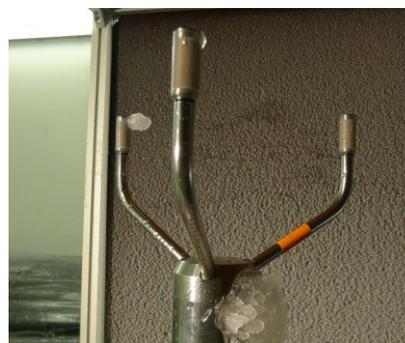
**Figure 4.** UUT after icing period. Translucent ice formed on surfaces facing wind.

With the A-procedure ice accumulation continued for 90 minutes. The ice growth was monitored every 15 minutes. Ice formed on the structures that were facing wind and back side remained without ice cover or with very limited ice cover. The structure of ice was solid and translucent. The icing period provided the ice layer from 27 to 29 mm on non-heated structures, while on the tube of the UUT the ice layer was between 24 and 27 mm.

After the intended ice accumulation of 25 mm was achieved, the water spray was halted. However, the air flow remained on for next 30 minutes. In addition, to ice layer on sensor body and other non-heated structures facing wind, there was a small ice ball on the top of one transducer stack. This ice ball attached to the metal part on top of the equipment. The sensor arms remained ice free during this icing period. Further, the silicon surfaces producing and receiving ultrasound were without ice.

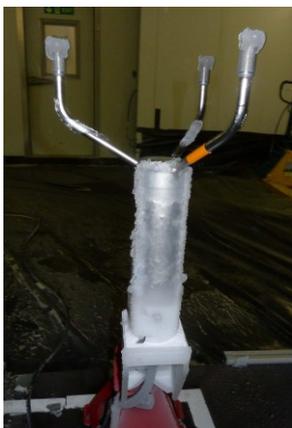
**Figure 6.** UUT after icing period. Ice layer on non-heated structure was 12 mm, while sensor tube has an ice cover of 8 mm.

With the B-procedure ice accumulation continued also for 90 minutes. The ice growth was monitored every 15 minutes. Ice formed on the structures that were facing wind and back side remained without ice cover or with very limited ice cover. Again the structure of ice was solid and translucent. The icing period provided the ice layer from 12 to 14 mm on non-heated structures, while on the tube of the UUT the ice layer was between 8 and 9 mm.

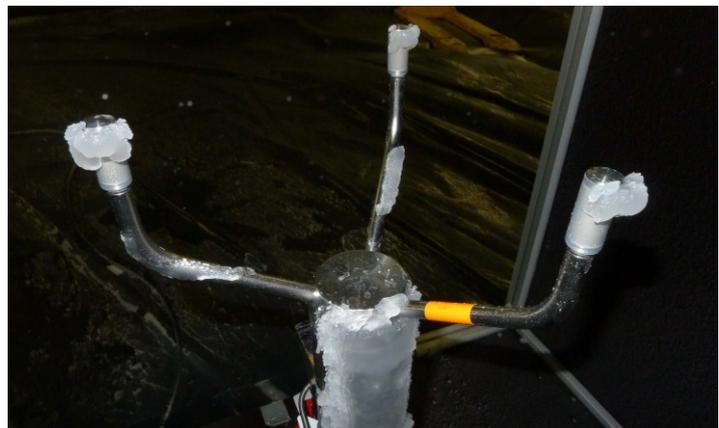
**Figure 7.** UUT after icing period. Translucent ice formed on surfaces facing wind. UUT was providing data.

After the intended ice accumulation of 12 mm was achieved, the water spray was halted. However, the air flow remained on for next 30 minutes. In addition, to ice layer on sensor body and other non-heated structures facing wind, there was some ice on the top of one transducer stack. This ice attached to the metal part on the top of equipment. The sensor arms remained almost ice free during this icing period. Further, the silicon surfaces producing and receiving ultrasound were in practice without ice.
